UNMANNED AERIAL VEHICLE (UAV)-BASED PRECISION AS-BUILT SURVEYING FOR INSTITUTIONAL BUILDINGS

Ogundele O.S., Sulaiman A.D., Ajadi, T.O., Ayanwole Ridwan A., Godwin, G.O.

JOURNAL OF SPATIAL INFORMATION SCIENCES ISSN: 2354-3361
VOL. 2, ISSUE 3, PP 138–150, 2025 **DOI:** https://doi.org/10.5281/zenodo.17244995
PUBLISHED 01-10-2025

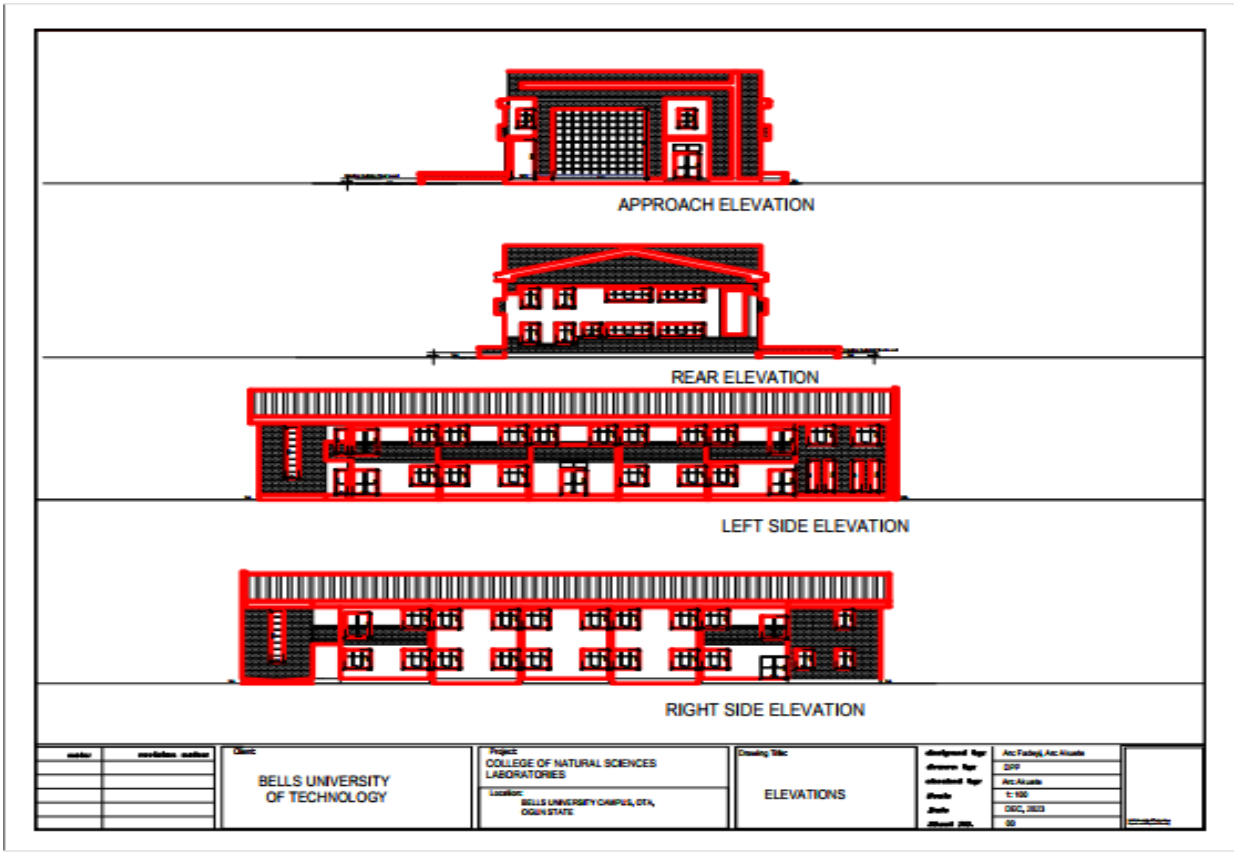
Figure 4: Architectural Design for Laboratory I & II

4	Roof (1) length analysis of Laboratory the (Rear view) 	Roof length analysis of Laboratory the (Rear view) 	The building roof length is specified as 42.99 m in the architectural drawing, while the orthophoto measurement indicates 42.90 m, resulting in a 0.09m deviation. This discrepancy exceeds acceptable tolerance limits, confirming non-compliance with the intended design specifications.
5	Door width of Lab 	Door width of Lab 	The door width measurement of a major entrance for architectural design is 1.652m while the orthophoto is 1.650m. this falls within acceptable tolerance.
6	Roof (2) width of Lab (side view) 	Roof width of Lab (side view) 	The measured roof width from the architectural drawing is 18.20m, whereas the orthophoto measurement is 18.10m, indicating a deviation beyond acceptable tolerance limits. This discrepancy clearly demonstrates that the constructed roof does not conform to the intended design specifications.
